Final Report

STUDY OF BREAK-AWAY SIGN BASE CONNECTIONS, II

State Job No. 99700-3593-119

Florida Institute of Technology

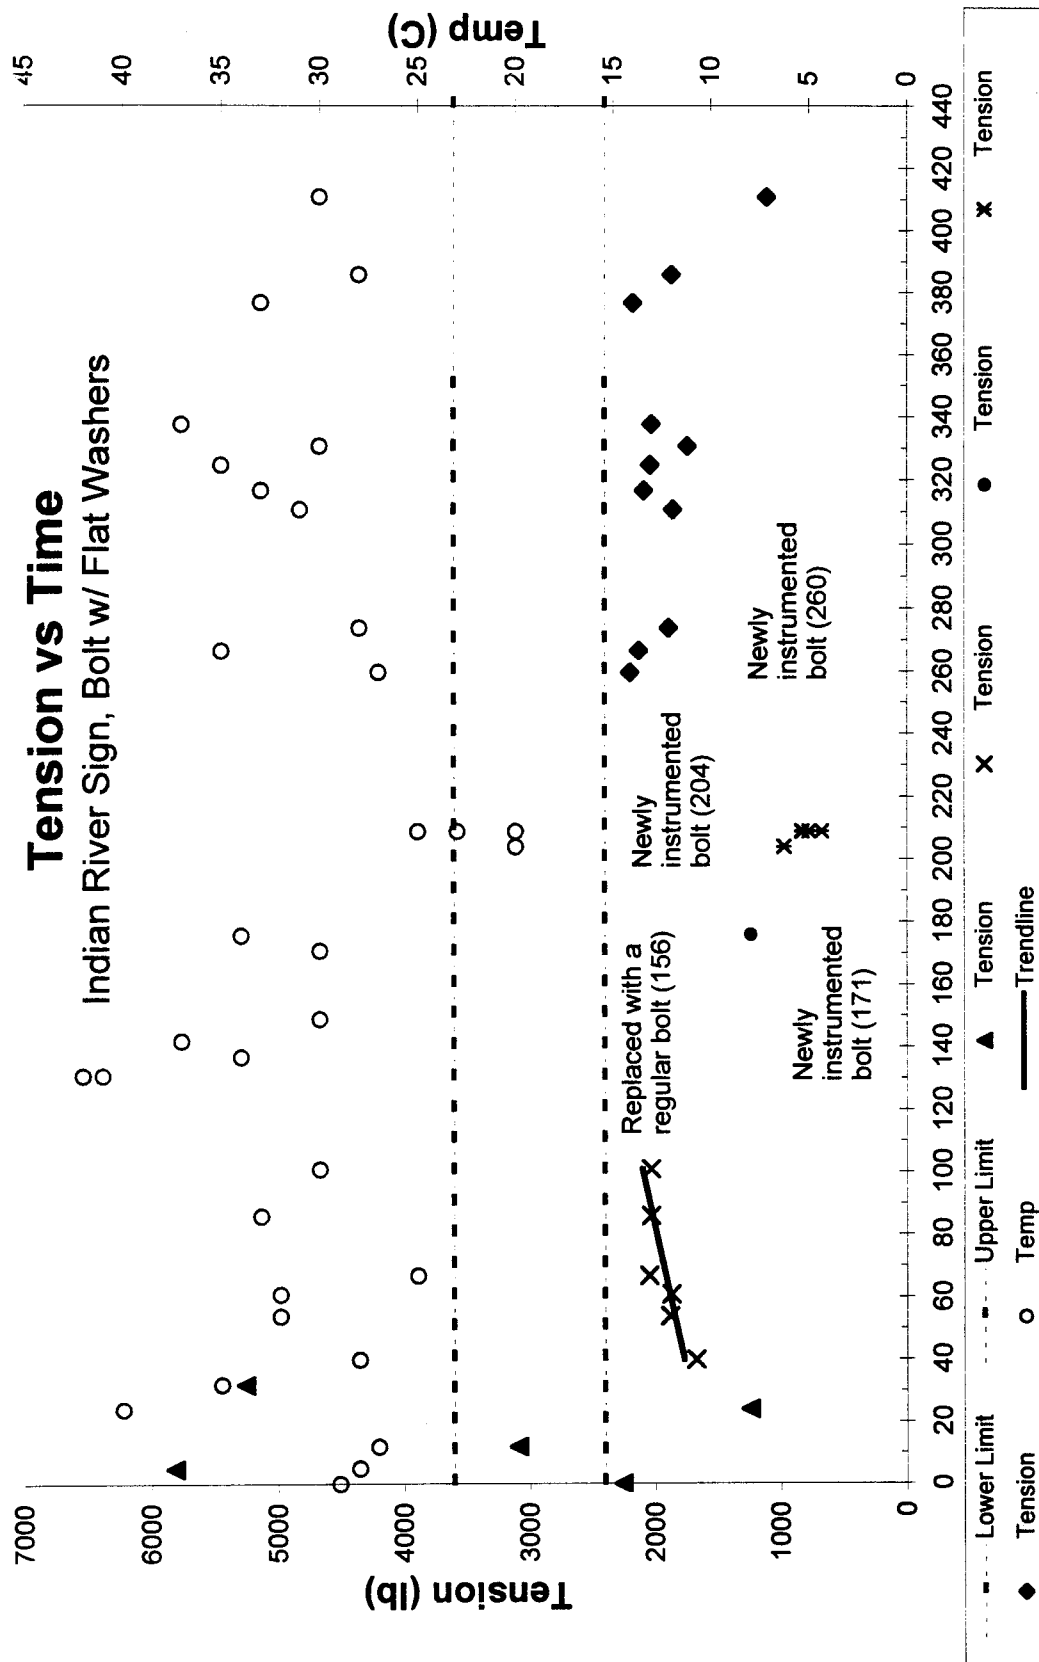
Days
Figure 45 Tension vs Time, Indian River Sign, Bolt with Flat Washers

For the Indian River bolt with spring washers, the readings from May 15, 1998 through June 9, 1998 were all under the lower limit of 2400 lb. The bolt was then re-installed and it maintained the tension within the acceptable range (2400 lb. to 3600 lb.) from June 1998 through early December 1998. From June 17, 1998 through January 18, 1999 the left strain gage read a negative strain indicating that the bolt was subjected to a combination of tension and bending. This is reflected in the big eccentricities in the readings.
